# Manhole Inspection Summary

Manhole # S37II\_018MH

Insp Date: **3/16/07 10:18 AM**

**Location** Address: **1702 BRENTWOOD AVE**

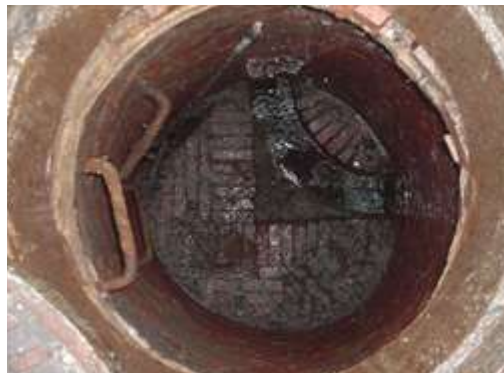
Top View

Corroded steps. Evidence of surcharge - Bench debris. Channel debris.

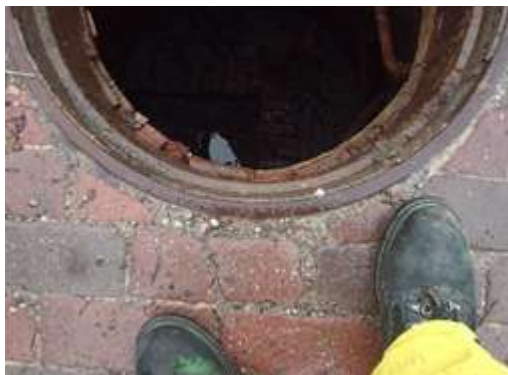
Defect

Frame leaks. Frame offset.

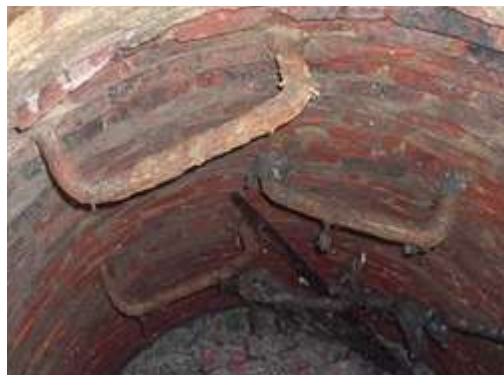
Defect

Adjustment, Corbel and Barrel infiltration.

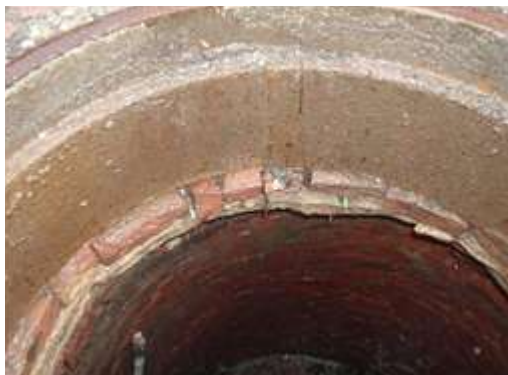
Defect

Frame leaks. Adjustment deterioration and infiltration.

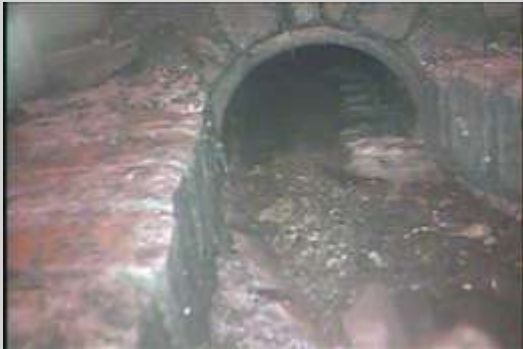
### 8 in. Circular Gravity Sewer Pipe Out @ 12 O'Clock

Deposits: ☐ None ☒ **Mud** ☐ Sludge ☒ **Debris** ☐ Grease

Silt Depth: **2** (in.) Deposits Extent: **Light**

Infiltration: **Evidence** Pipe Seal Cond: **Unknown**

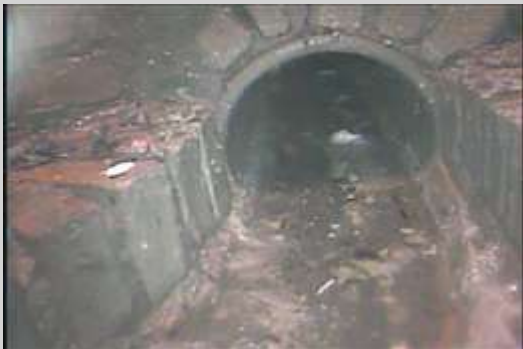
### 8 in. Circular Gravity Sewer Pipe In @ 3 O'Clock

Deposits: ☐ None ☒ **Mud** ☐ Sludge ☒ **Debris** ☐ Grease

Silt Depth: **1** (in.) Deposits Extent: **Light**
